Underground Tanks

According to DIN 6608 (DIN EN 12285-1)

Underground storage tanks made of steel

Information on the temporary storage of underground tanks from Dehoust with an external polyurethane coating and use of the repair kit Endoprene 880 (art. no. 10214)

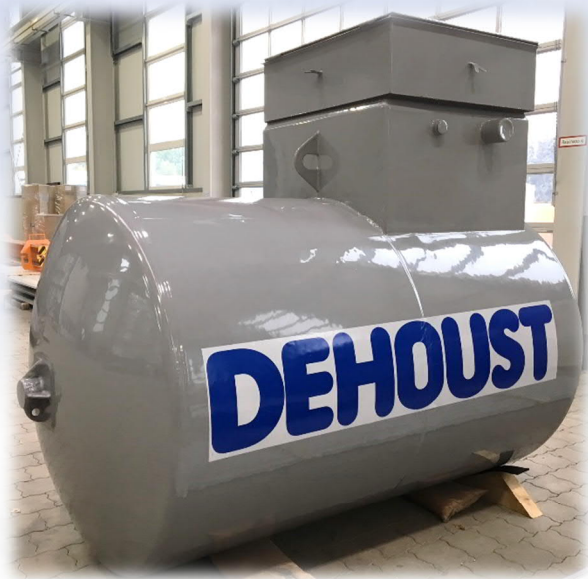
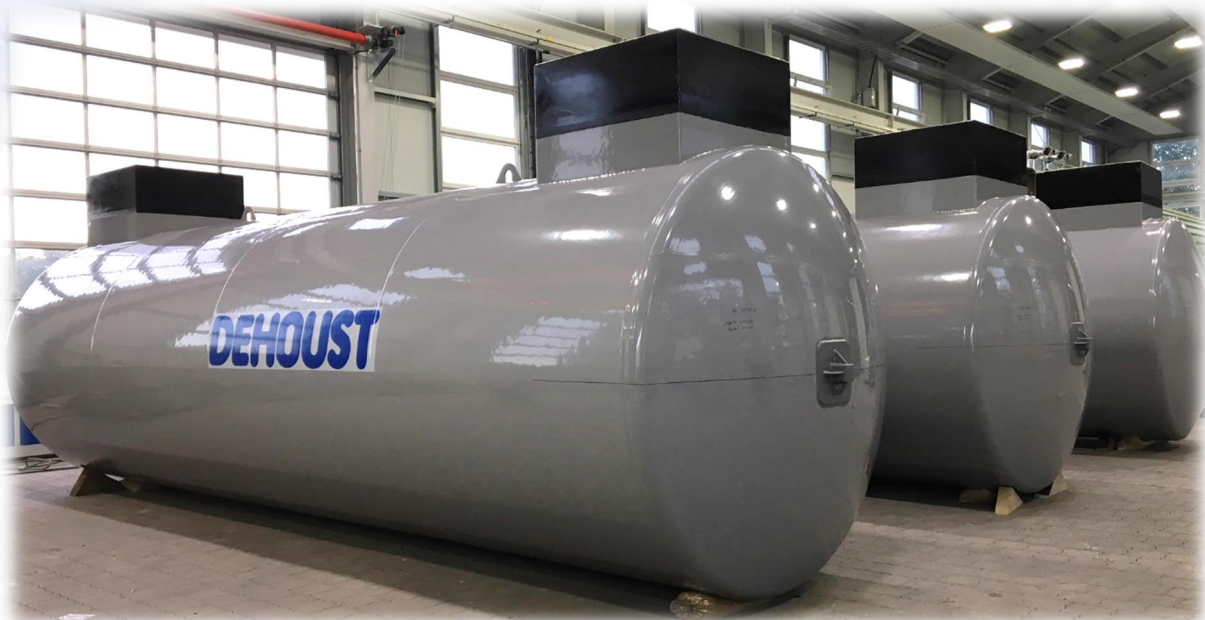
Double wall cylindrical steel storage tanks according to DIN 6608/2 (EN 12285-1) for the underground storage of liquids hazardous for waters as for example heating oil or carburettor fuels (see material list DIN 6601) have been proven and tested for decades.

The double shell is continuously monitored by means of vacuum (or with excess pressure) and thus offers long-term safety. The tanks are protected against external corrosion by Endoprene insulation. A high-voltage test of 6000 volt in the works guarantees additional security.

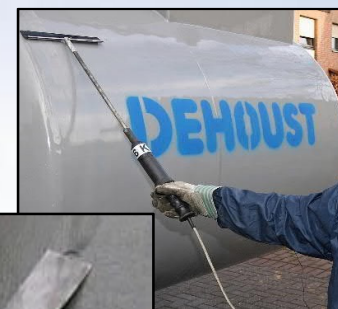
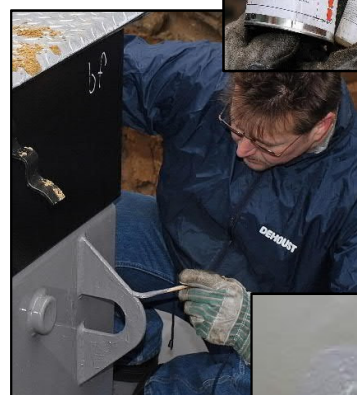
Use of a repair kit:

The sticking particles are completely removed with appropriate means (scraper), followed by a matt grinding or brushing of the peeled off surface and the adjacent area on a width of 50mm.

Application on the entire defect and the adjacent area by means of a scraper or a brush. Layer thickness:1000µm.
